3.0 Affected Environment, Environmental Impacts and Mitigation

3.1 Aesthetics (I)

Visual Simulations

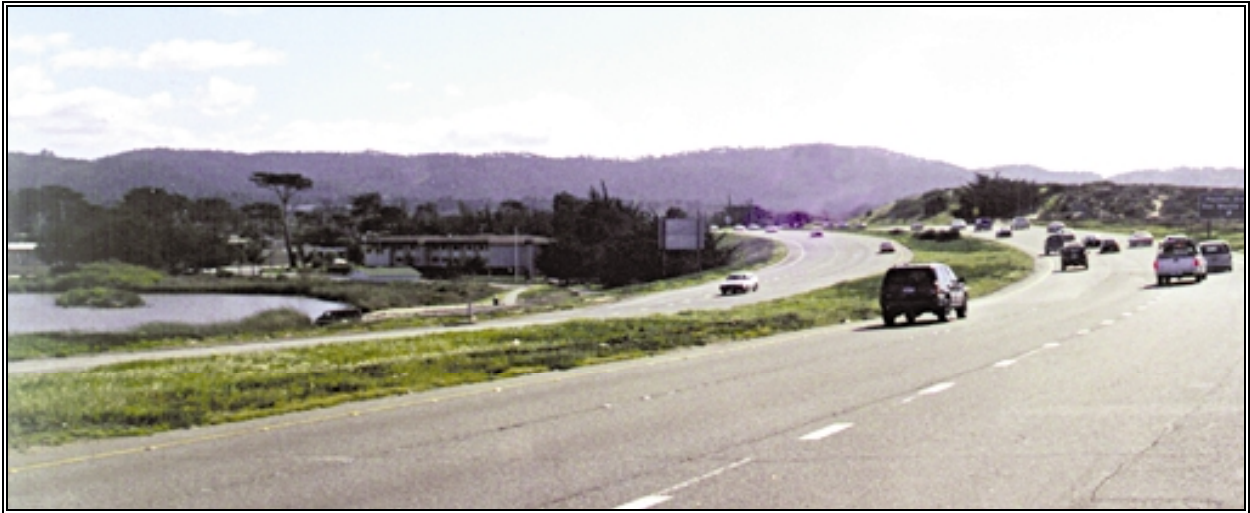
Observer Viewpoint #1

Existing—This viewpoint represents how the project area appears to southbound highway travelers near Robert's Lake. The background of undulating hills of dense dark green pine forest against the valley combine for a moderately high vividness rating. The alignment of the roadway meanders through the landform to obtain a moderate intactness and unity rating. The low grey/green sprawling coastal dune vegetation extends from one side of the roadway to the other unifying this corridor.

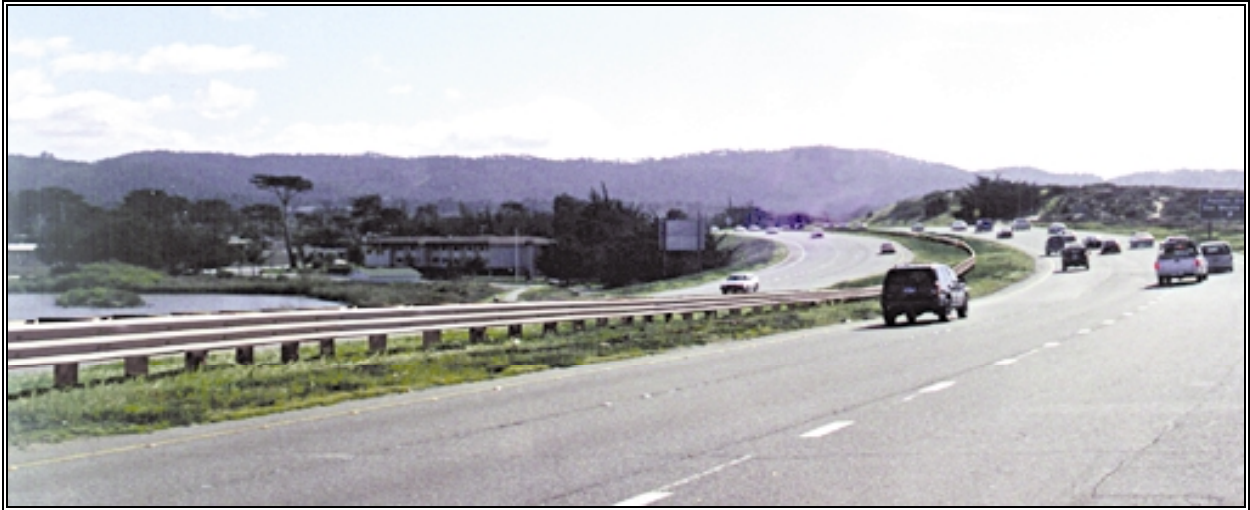
Observer Viewpoint #1

Proposed—The proposed improvement represents how double thrie beam installed in the center of the median would appear to highway travelers. The construction of the double thrie beam would add another vertical man-made element to the landform. Vividness would be moderately compromised due the thrie beams foreground relationship to Robert's Lake. Intactness and unity would be equally reduced by the introduction of a vertical man-made object that divides the landform.

<u>Viewpoint #1</u>	<u>Vividness / Intactness / Unity = Visual Quality (VQ=V+I+U/3)</u>				
Existing	5.7	5.4	5.5	=	5.5
Proposed	5.0	4.9	5.0	=	5.0
Visual Quality Difference				=	-0.5

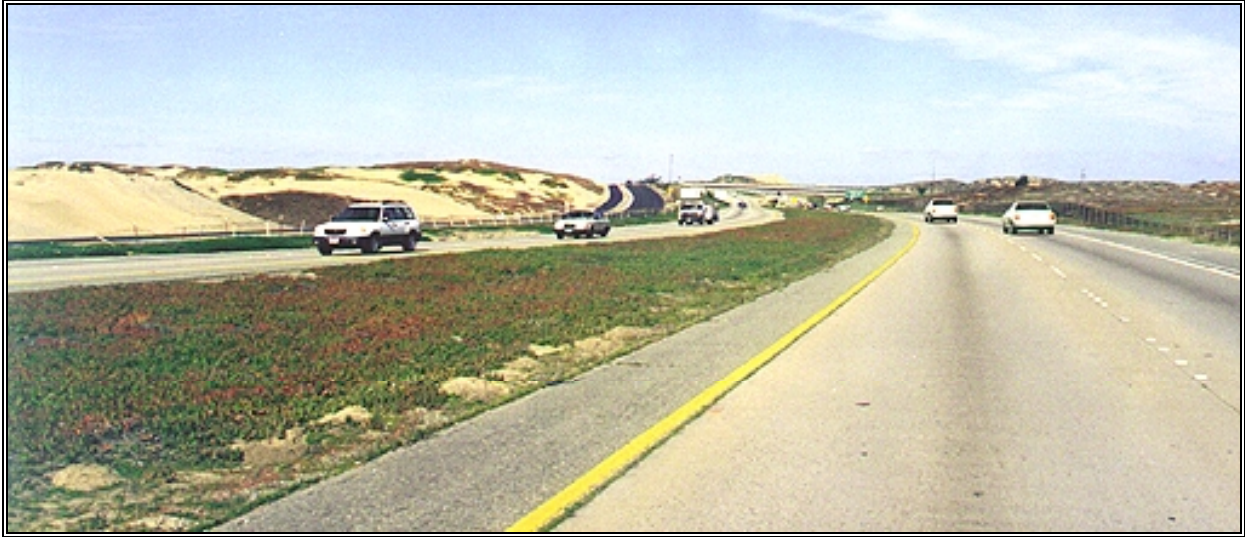
Observer Viewpoint #2

Existing—This viewpoint represents how the project area appears to northbound highway traveler's midway between the Humboldt St. Undercrossing and Tioga Ave. Overcrossing. The large rounded sand dunes are covered in a mosaic of low growing dune plant communities. This results in a moderately high vividness and unity rating. The intactness rating is moderate due to the frontage road encroachment, power poles, and fence line in the background.

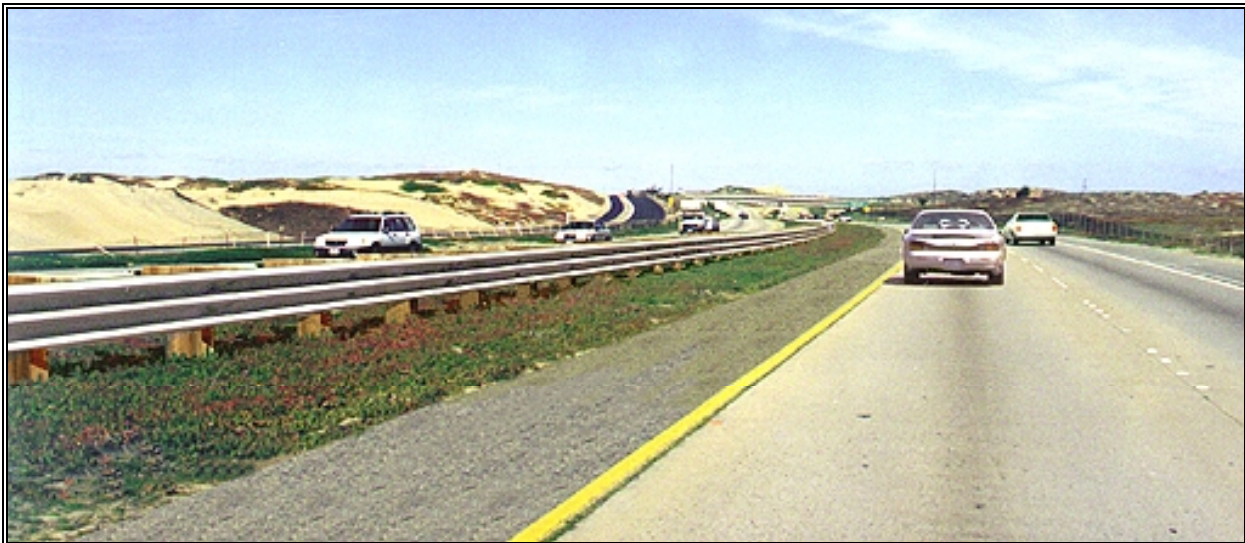
Proposed—The proposed improvement of a double three beam in the center of the median would negatively affect the area in all three categories. The loss of vegetation along the inside shoulders and reducing the width of the median would lower the vividness and the intactness of the area. Unity would be minimally affected.

Viewpoint #2 Vividness / Intactness / Unity = Visual Quality (VQ=V+I+U/3)

Existing	5.8	5.5	5.7	=	5.7
Proposed	5.4	5.1	5.6	=	5.4
Visual Quality Difference				=	-0.3

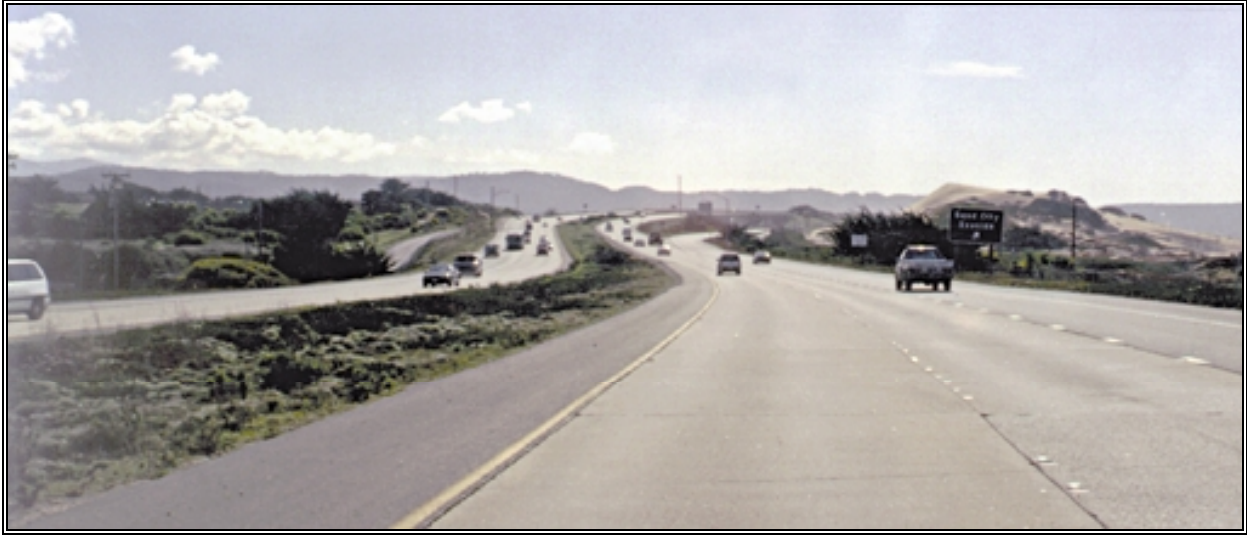
Observer Viewpoint #3

Existing—This viewpoint represents how the project area appears to southbound highway travelers near the Fremont Boulevard/Del Monte Boulevard Exit. The roadway acts as a divider of foredune and backdune plant communities. This view exemplifies the character of the northern section of the project. There are sweeping vistas, undulating landforms and varying vegetation types in this area, providing memorable experiences. The picturesque scene has a high level of intactness and unity for all users.

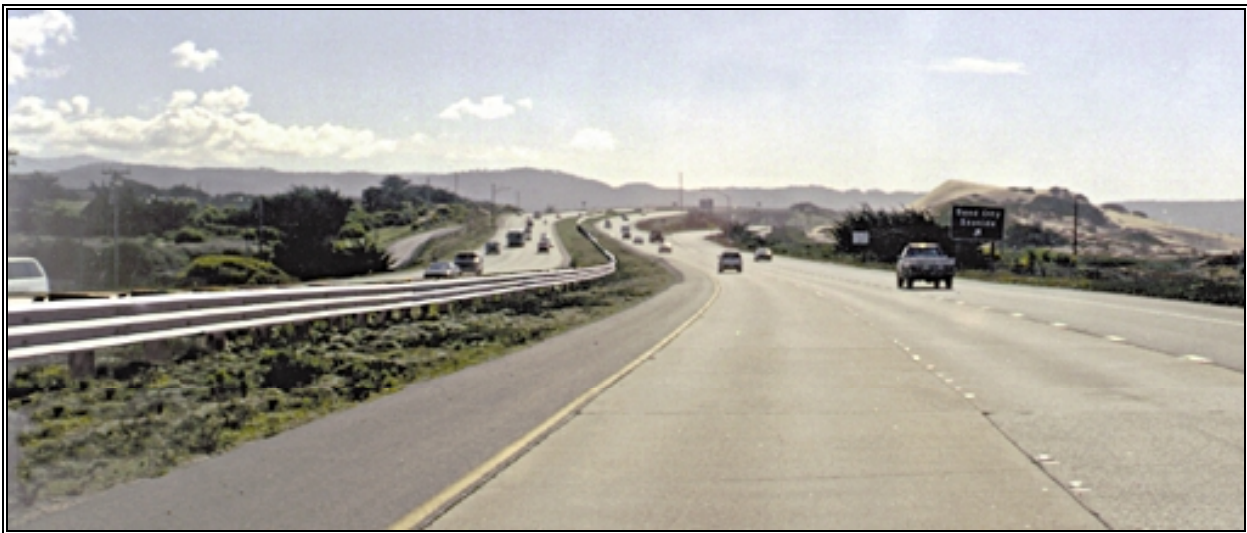
Proposed—All three evaluative criteria would be moderately affected by the installation of the double white line barrier. The barrier would accentuate the separation of vegetation, landform, and man-made lines.

Viewpoint #3	Vividness / Intactness / Unity = Visual Quality (VQ=V+I+U/3)			
Existing	5.8	5.6	5.7	= 5.7
Proposed	5.3	5.1	5.2	= 5.2
Visual Quality Difference				= -0.5

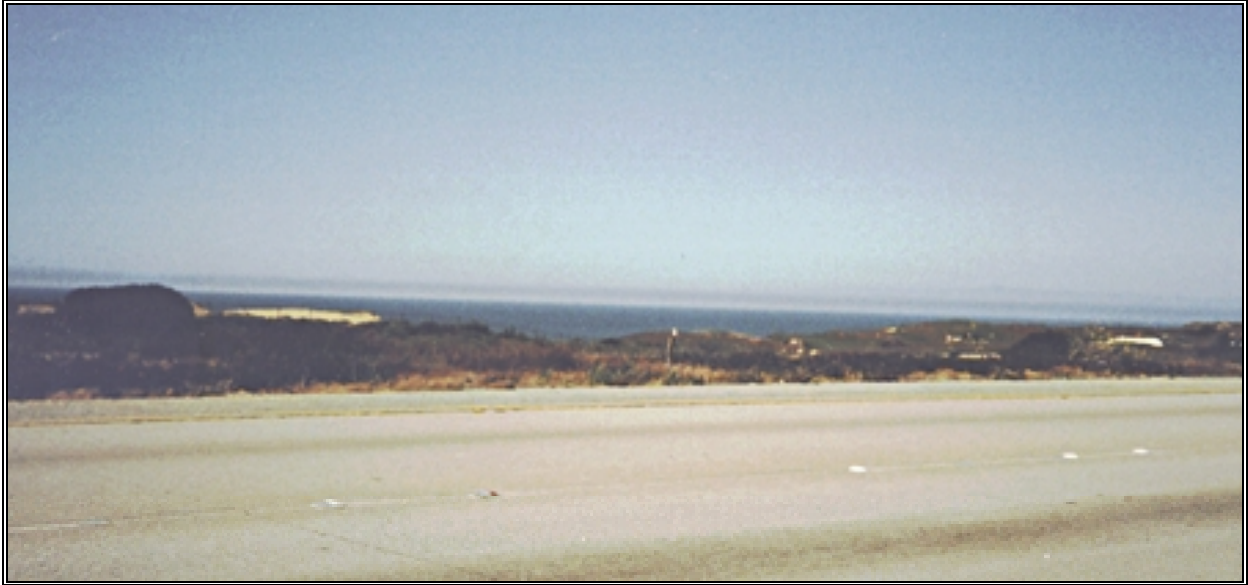
Observer Viewpoint #4

Existing—This viewpoint was identified for its beautiful panoramic view of Monterey Bay. The sweeping backdrop of the Monterey Bay sets off the coastal dune community. The moderately high rating of intactness and unity complements the high level of vividness.

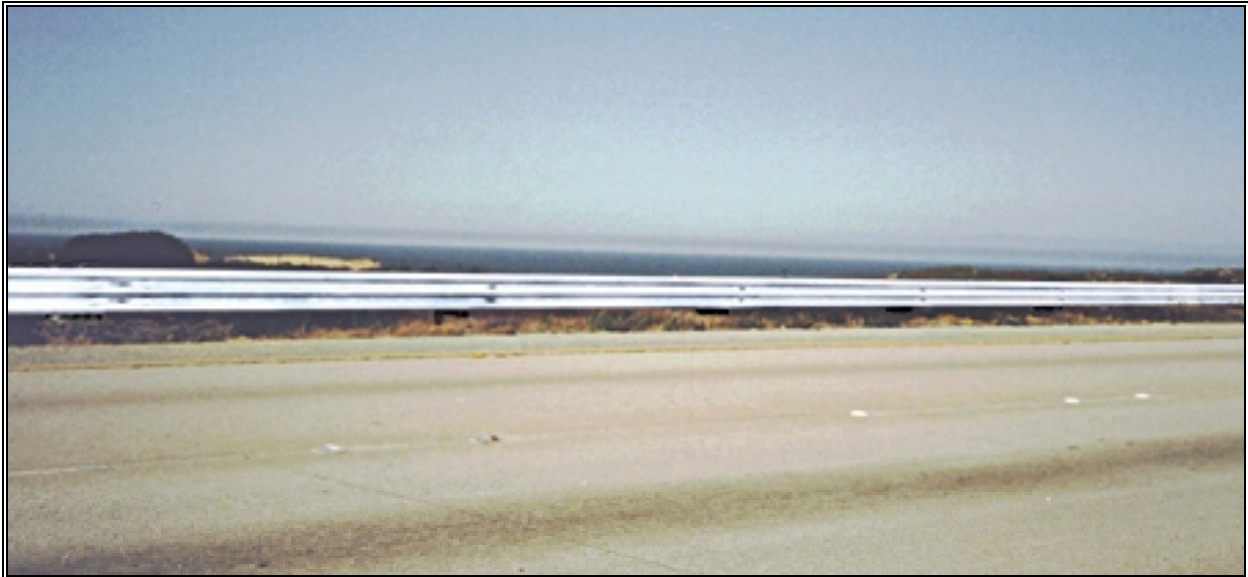
Proposed—The proposed three beam barrier would partially obstruct views to the ocean for a period of 2-3 seconds to northbound travelers. This experience would increase awareness of the barrier in this area more than in other locations. Since the three beam would noticeably effect views; vividness, intactness and unity would subsequently be reduced.

Viewpoint #4 Vividness / Intactness / Unity = Visual Quality (VQ=V+I+U/3)

Existing	6.0	5.7	5.8	=	5.8
Proposed	4.9	4.7	5.0	=	4.9
Visual Quality Difference				=	-0.9
